Material in this publication relating to
DUAL ORIFICE INJECTION, LAMINATED
CHAMBER COOLING MEANS, and A VARIABLE
AREA INJECTOR CONCEPT

(U) The electrical ignition systems were also defined as a part of the control task and these systems are described in this Section. The ignition system performance is reported in the preburner and main burner test Sections.

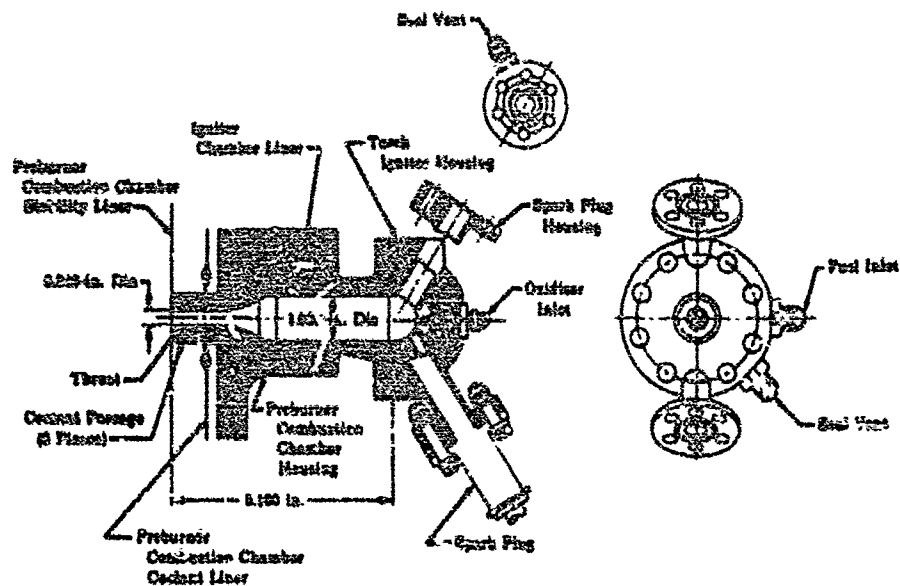
(U) The preburner torch igniter, shown in figure 531, was a hydrogen-cooled, continuous-burning, oxygen-hydrogen, electrically ignited device. This ignition system was designed to operate at either sea level or in a vacuum, with either gaseous or liquid propellants, and was capable of multiple relights. The flame from the torch was ignited prior to the initiation of preburner propellant flow to prevent excessive propellant accumulation inside the combustion chamber.

Figure 531. Preburner Igniter Assembly

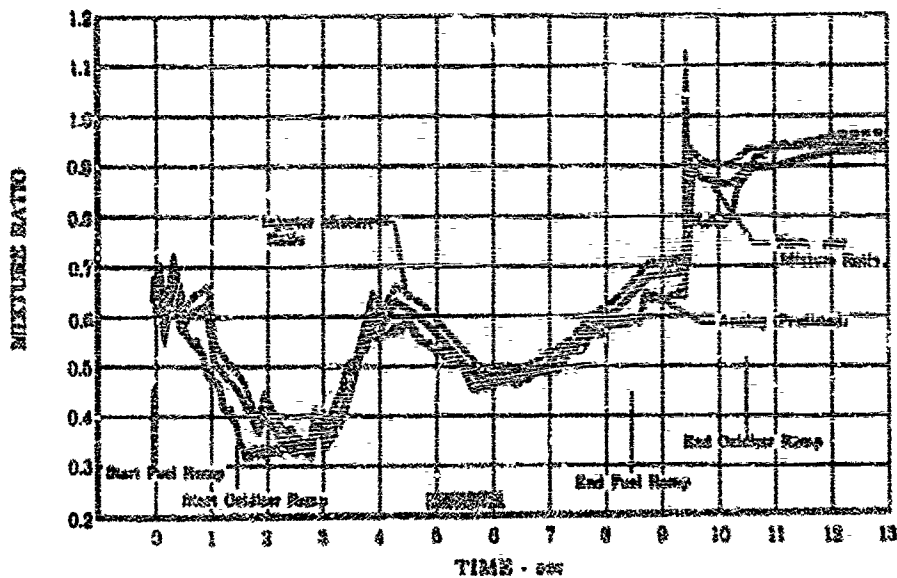
injector mixture ratio was made from the first series of tests. The small variation from the preset mixture ratio noted during the transient, as shown in figure 536, was caused by the overlap and flow characteristics of the facility valves.

Figure 536. 250K Preburner Mixture Ratio
Profile - Run 46 (Transient from
7% to 80% Rated Flows)

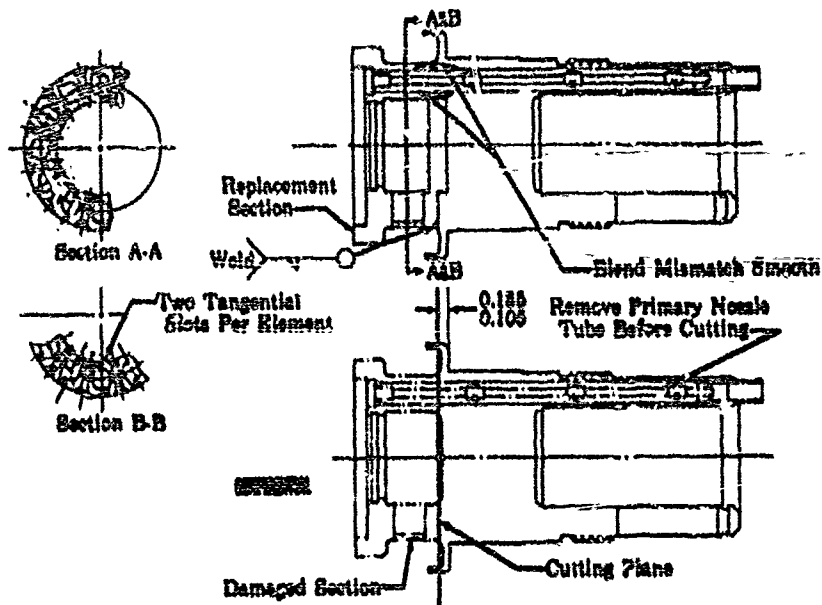
Figure 532. Schematic of 250K Preburner Injector Dual-Orifice Nozzle Assembly Showing the Replacement of Damaged Entry Slot Section FD 21408

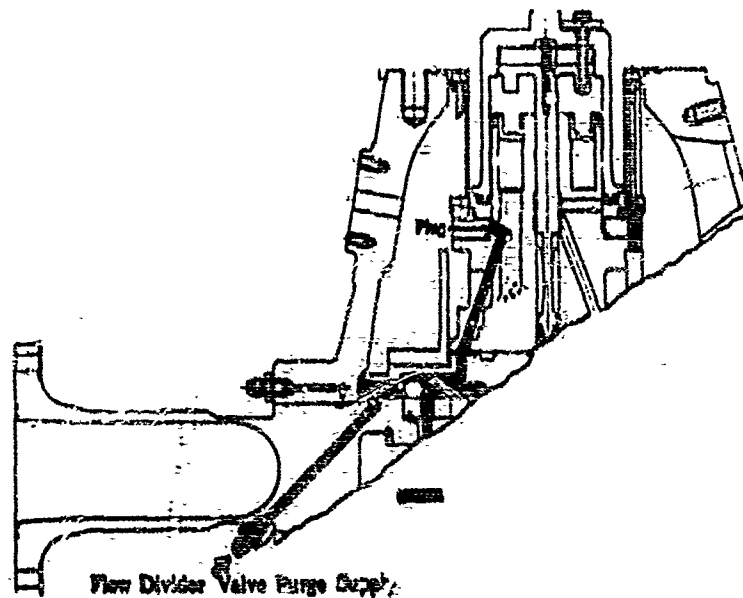
Figure 553. Revised 350K Preburner Injector
Oxidizer Purge Schematic

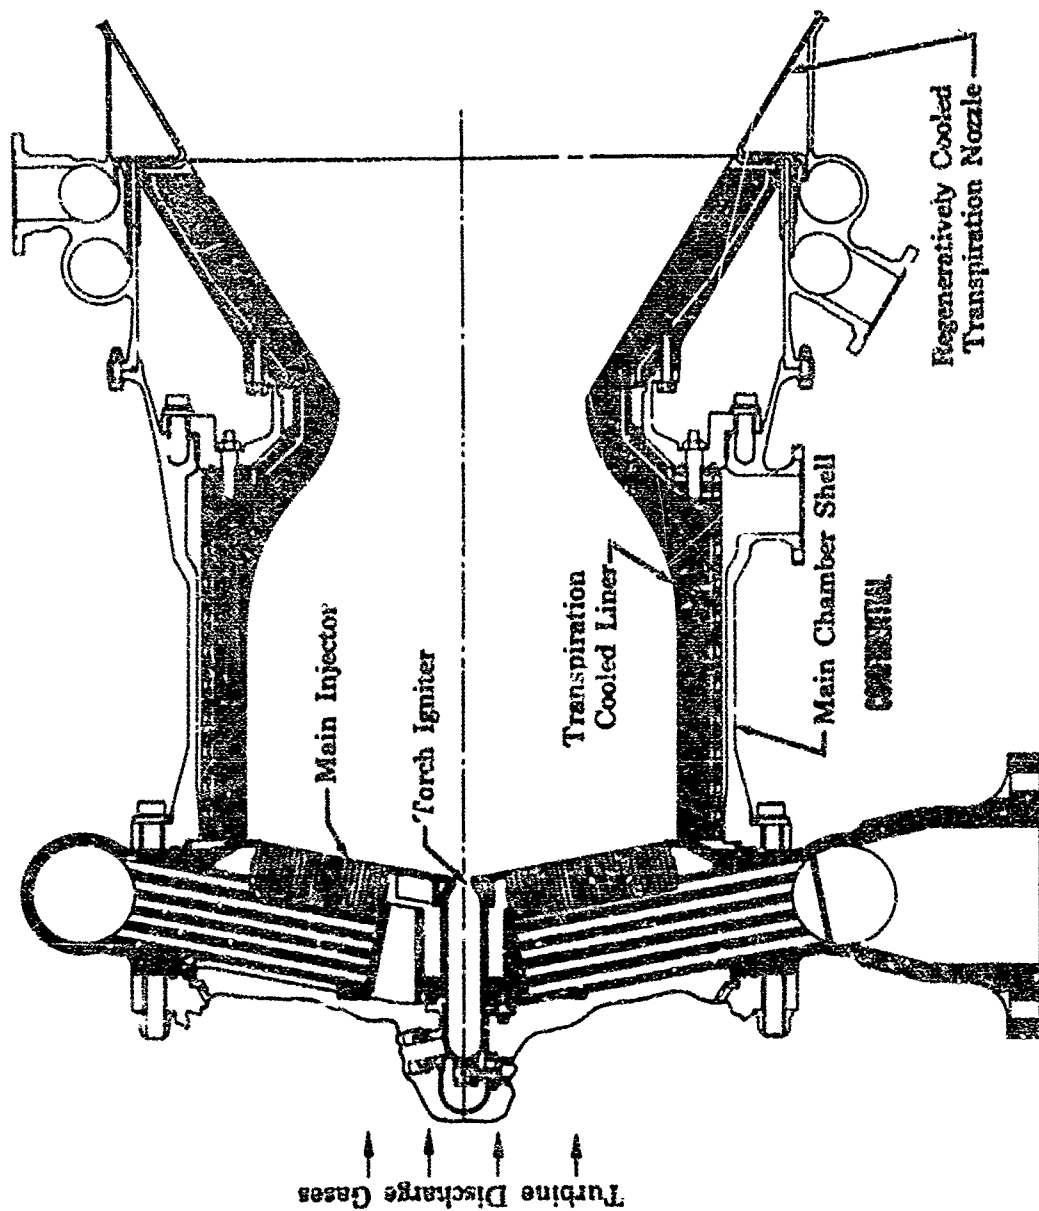
Figure 573. Main Burner

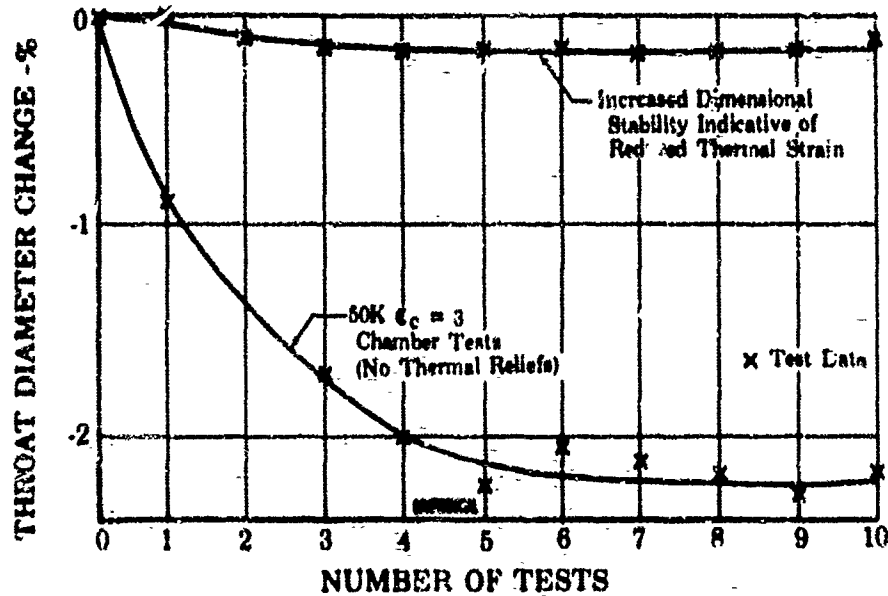
Figure 590. Demonstration of Cooled Thrust Chamber Thermal Strain Relief

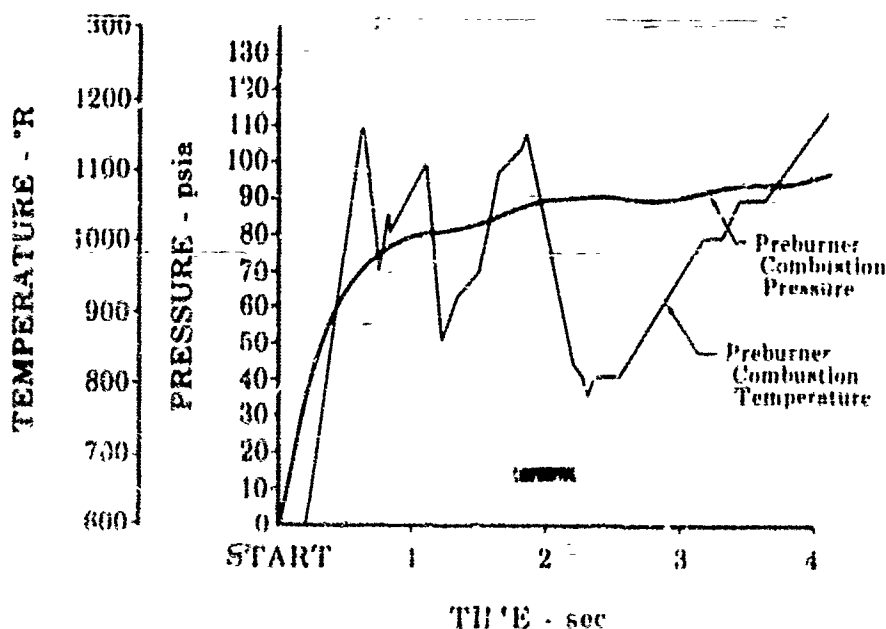
Figure 599. Test No. 15 Preburner Temperature and Pressure

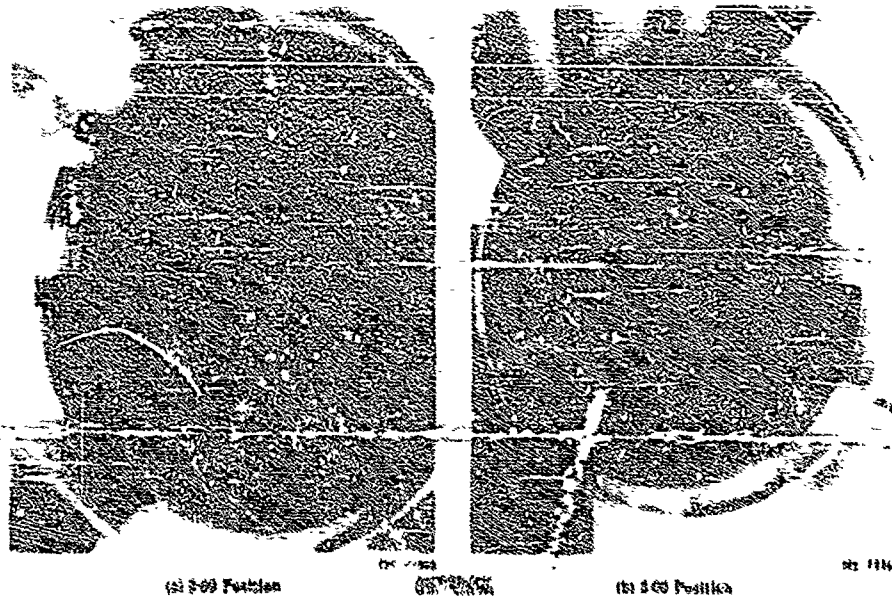
Figure 616. Pretest Condition of Main Chamber
